4.3.7 FY96-02 Replacement

4.3.7.4 Unit Type FY96-02.2 Fy96-02 Replacement

Base Name: Holloman Air Force Base

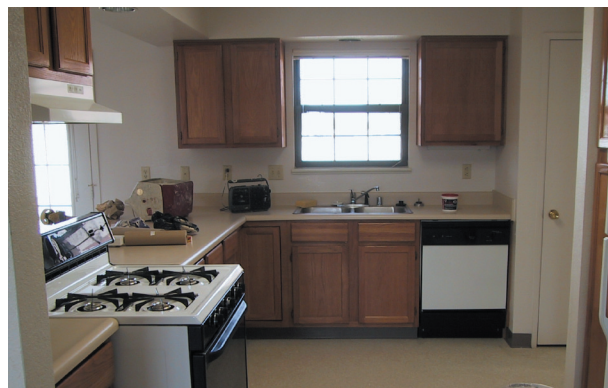
Kitchen

- Cabinets: wood; good condition.
- Counter Tops: laminated; fair condition; one bad seam, and a few chips at edge of counter.
- Sink: stainless sink, double; good condition.
- Sink Fixtures: metal; good condition.

- Refrigerator: standard; good condition.
- Range/Oven: gas; good condition.
- Vent Hood: exhaust fan; good condition.
- Dishwasher: standard; good condition.
- Garbage Disposal: standard; good condition.
- Flooring: vinyl sheet; good condition.
- Walls: gypsum wall board; good condition.
- Wall Finish: painted; good condition; textured finish.
- Ceilings: gypsum wall board; good condition.
- Ceiling Finish: painted; good condition; textured finish.
- Interior Hardware: none; not required.

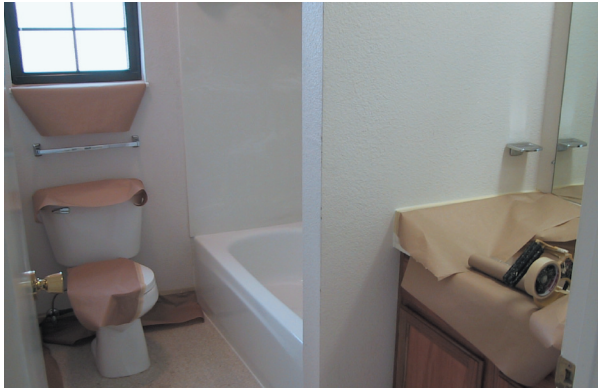
Bathroom 1

- Cabinets: wood; good condition.
- Counters: cultured marble; good condition.
- Sink: cultured marble; good condition.
- Fixture Hardware: metal; good condition.
- Toilet: porcelain; good condition.
- Tub/Shower: combination; good condition; cultured marble enclosure.
- Flooring: vinyl sheet; fair condition; slightly worn at toilet.
- Walls: gypsum wall board; good condition.
- Wall Finish: painted; good condition.
- Ceilings: gypsum wall board; good condition.
- Ceiling Finish: painted; good condition.
- Ventilation: exhaust fan; good condition; with window.
- Interior Hardware: metal; good condition.

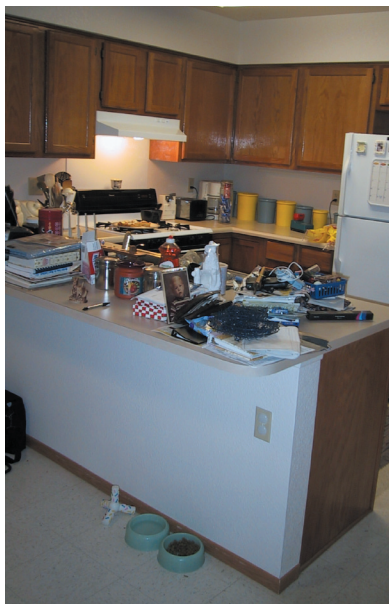
Kitchen

- Cabinets: wood; good condition.
- Counter Tops: laminated; good condition.
- Sink: stainless sink, double; good condition.
- Sink Fixtures: metal; good condition.
- Refrigerator: standard; good condition.
- Range/Oven: gas; good condition.
- Vent Hood: exhaust fan; good condition.

- Dishwasher: standard; good condition.
- Garbage Disposal: standard; good condition.
- Flooring: vinyl sheet; good condition.
- Walls: gypsum wall board; good condition.
- Wall Finish: painted; good condition; textured finish.
- Ceilings: gypsum wall board; good condition.
- Ceiling Finish: painted; good condition; textured finish.
- Interior Hardware: none; not required.
